Current Hazmon Field Situations

Concerning Existing Realities

Real-World Examples

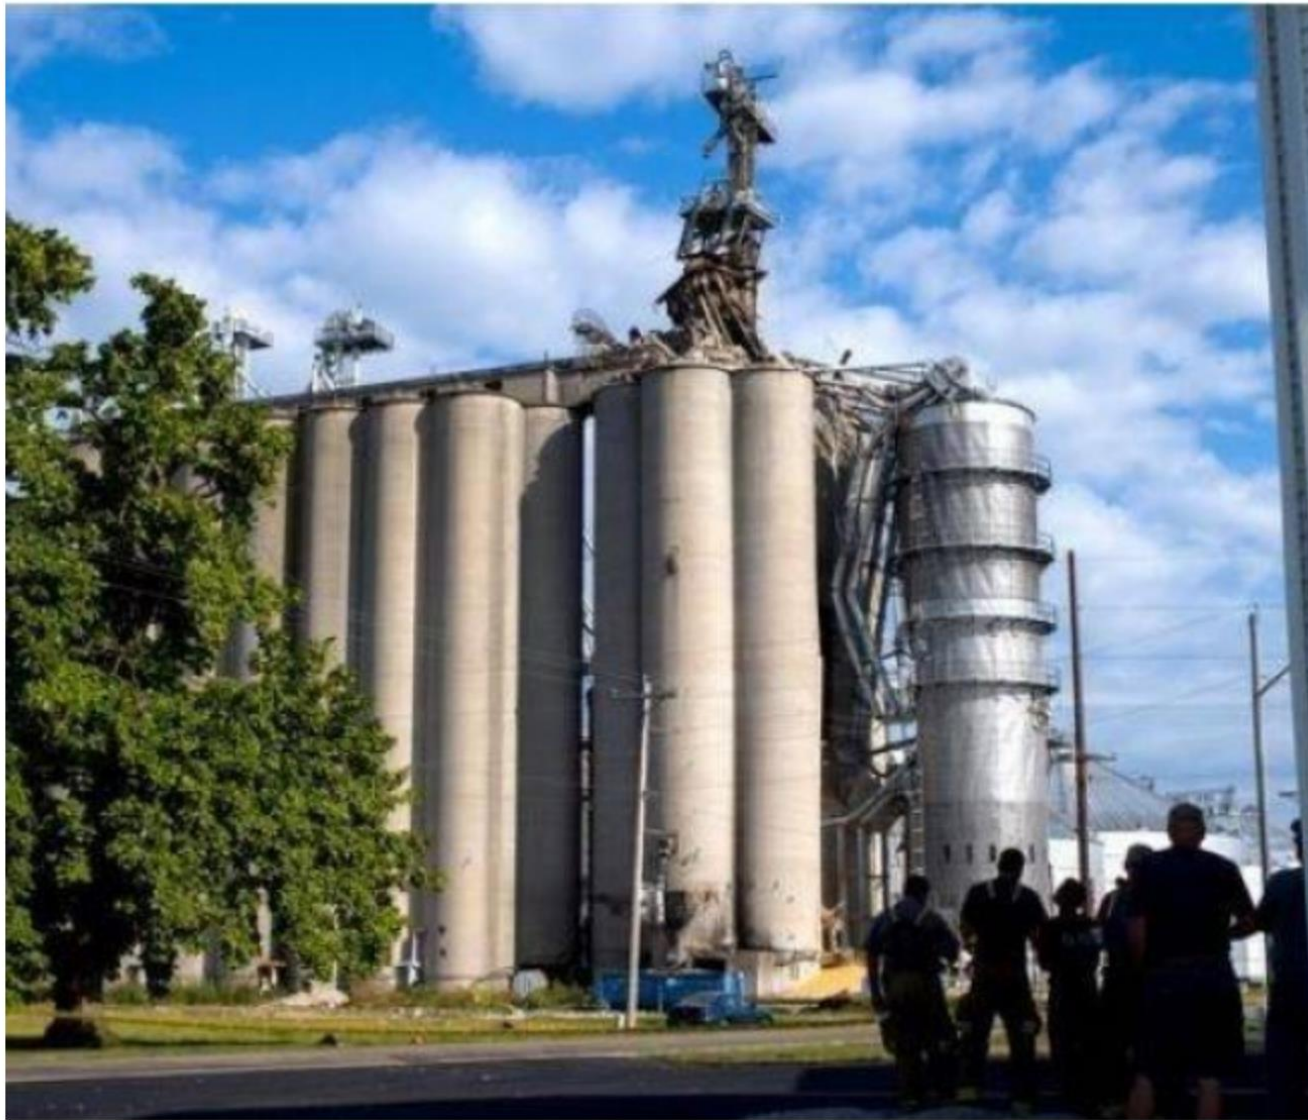
Illinois Elevator Explosion Could Have Been Worse

Debris field from the blast extended up to 500 feet

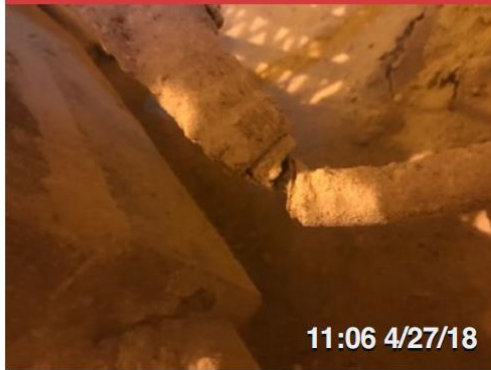
ISSUE 54

Assigned To Crossover Belt

The conduit on the shaft speed sensor is broken.

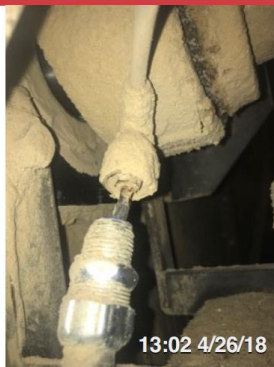
ISSUE 11

Assigned To Leg 1

The tail north bearing sensor conduit was not fully put together.

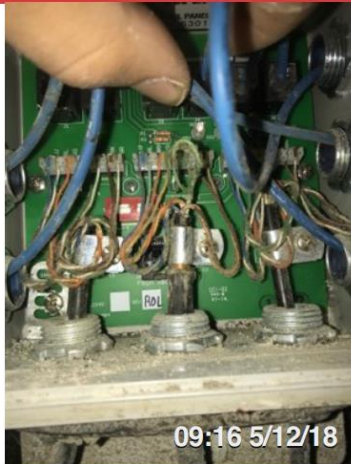
ISSUE 6

Assigned To South Leg

The tail Field Interconnect Box (FIB) is not grounded on the outgoing A and B branches.

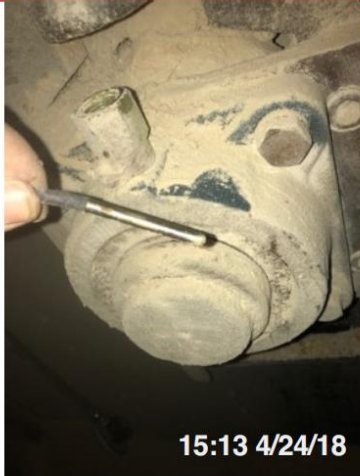
ISSUE 6

Assigned To Truck Leg

The tail north bearing sensor is not long enough to properly monitor the bearing.

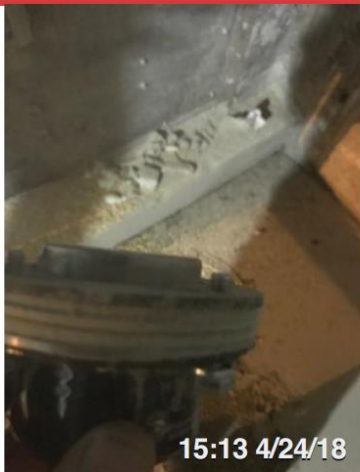
ISSUE 7

Assigned To Truck Leg

The tail north alignment sensor is flush with the casing. (Spacer was removed by CMC)

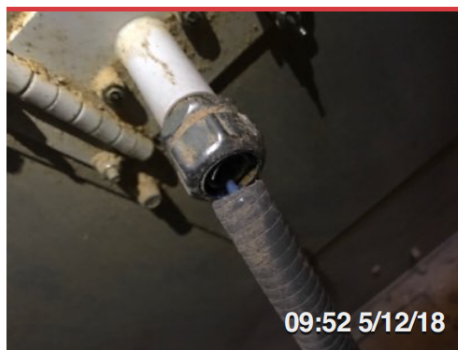
ISSUE 15

Assigned To East Leg

The tail west alignment sensor conduit is broken.

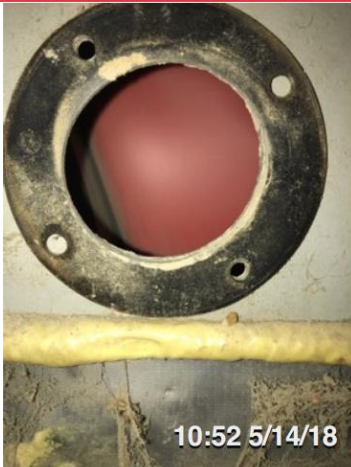
ISSUE 3

Assigned To Leg 4

The head north alignment sensor will not make contact with the belt.

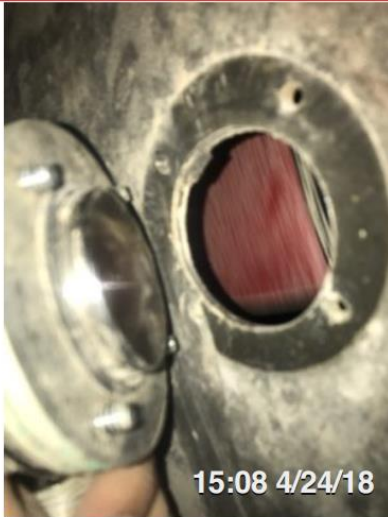
ISSUE 4

Assigned To Truck Leg

The tail south alignment sensor is flush with the casing. (Spacer was removed by CMC)

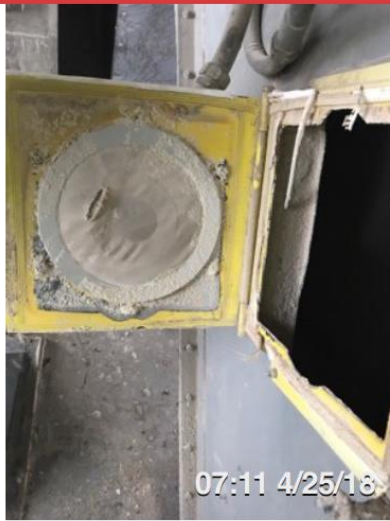
ISSUE 11

Assigned To Truck Leg

The plug sensor plunger does not move not allowing it to alarm.

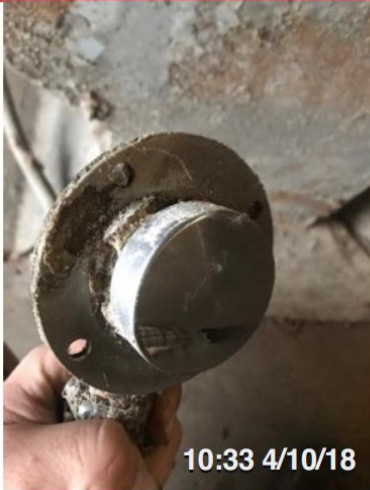
ISSUE 5

Assigned To Leg 3

The knee pulley north Touch Switch is packed with material and not able to compress to give alarms. (Sensor needs replaced)

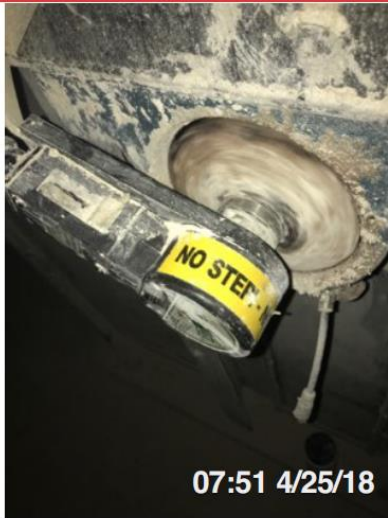
ISSUE 12

Assigned To East House Leg 3

The shaft speed sensor on the tail west bearing does nothing in the system.

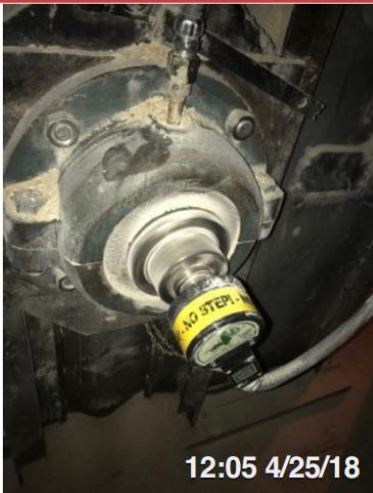
ISSUE 45

Assigned To East House Leg 2

The shaft speed sensor on the tail west bearing does nothing in the system.
